Manhole Inspection Summary

Manhole # S35YY_004MH

Insp Date: **12/22/06 12:27 PM**

Location Address: **200 32ND ST**

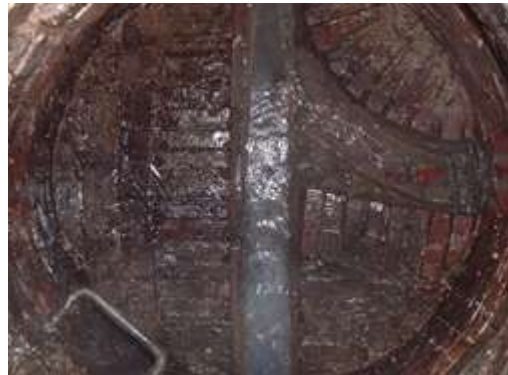
Top View

Bench and Channel debris.

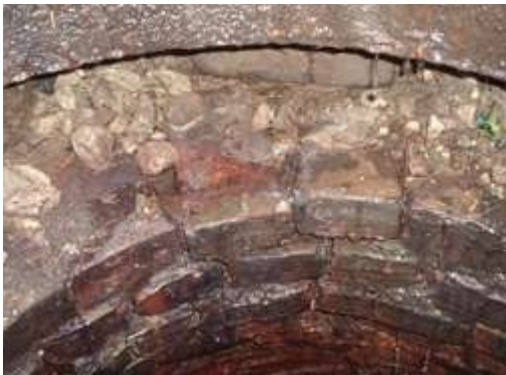
Defect

Frame leaks. Frame offset. Adjustment deterioration and infiltration.

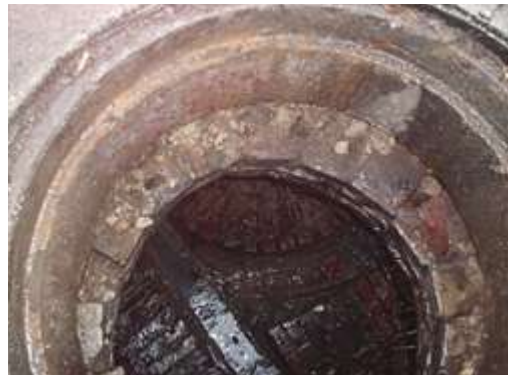
Defect

Frame leaks. Frame offset. Adjustment deterioration and infiltration.

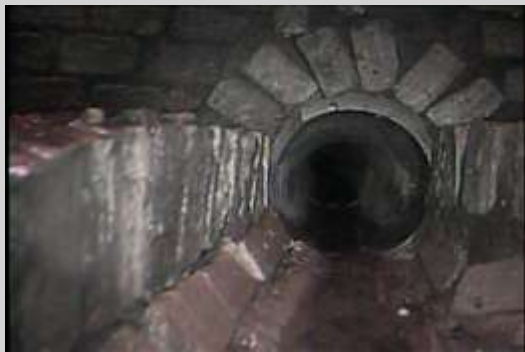
8 in. Circular Gravity Sewer Pipe Out @ 12 O'Clock

Channel deterioration.

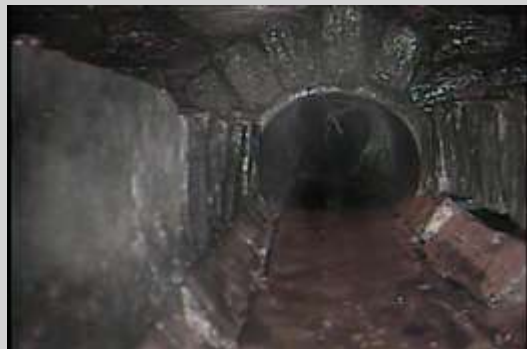
8 in. Circular Gravity Sewer

Infiltration: **Evidence**
